CHAPTER 2

NEW TEST SECTIONS

Five new test sections were constructed during the previous 2 years. The new test sections are:

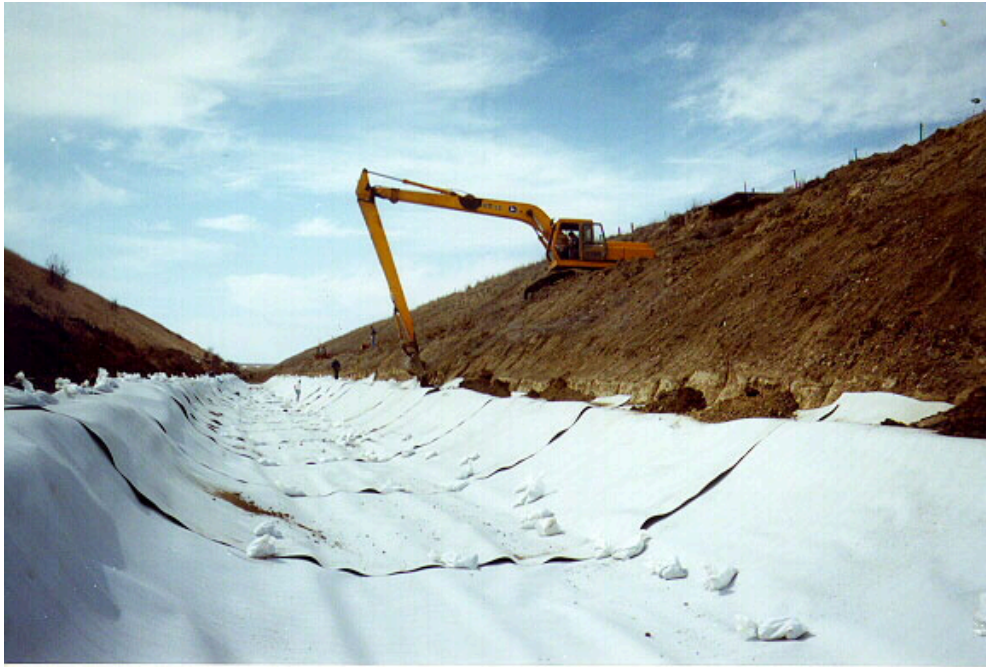
Photograph 15.—Sandbags are removed and moved upstream as the trackhoe backfills portions of the anchor bench. Backfill is not placed in the immediate vicinity of areas to be seamed.

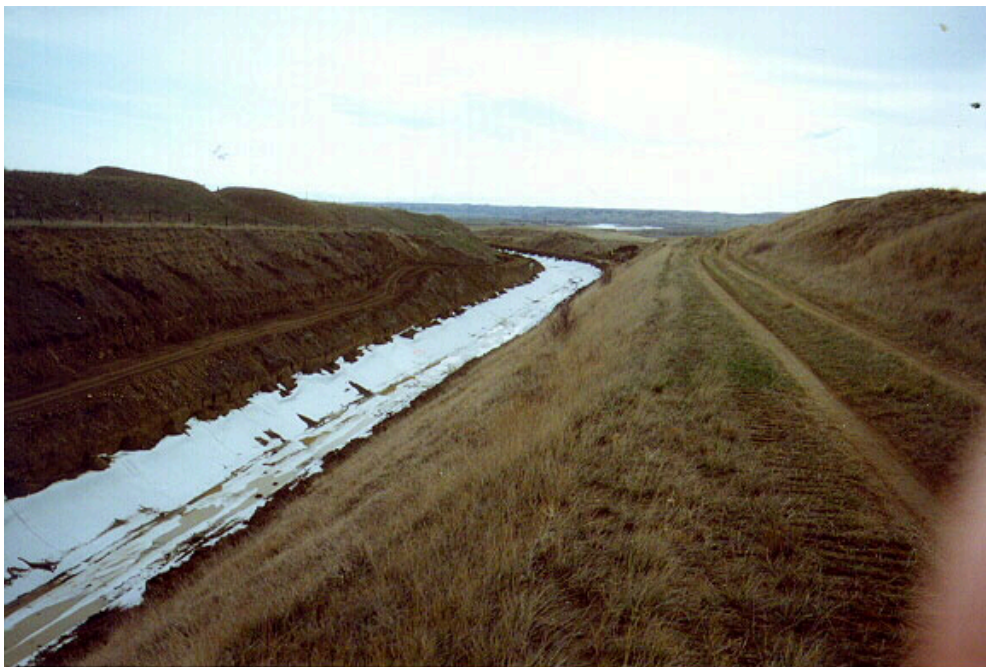
Photograph 16.—View from the top of the “Deep Cut” looking downstream.

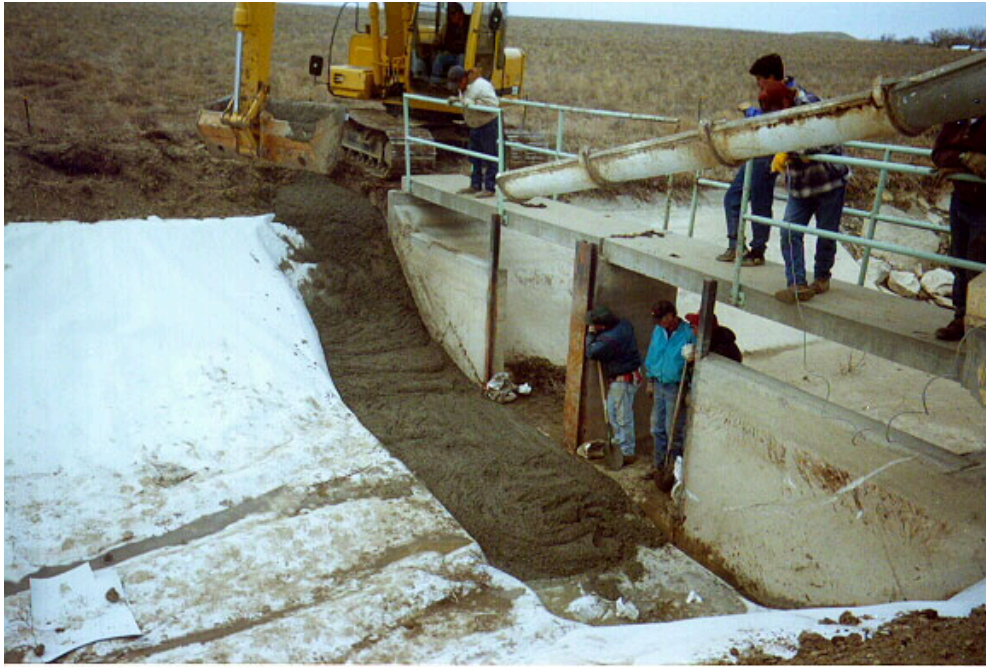
Photograph 17.—Cut-off trench at downstream check structure is filled with concrete and measures about 5 feet wide and 2 feet deep.

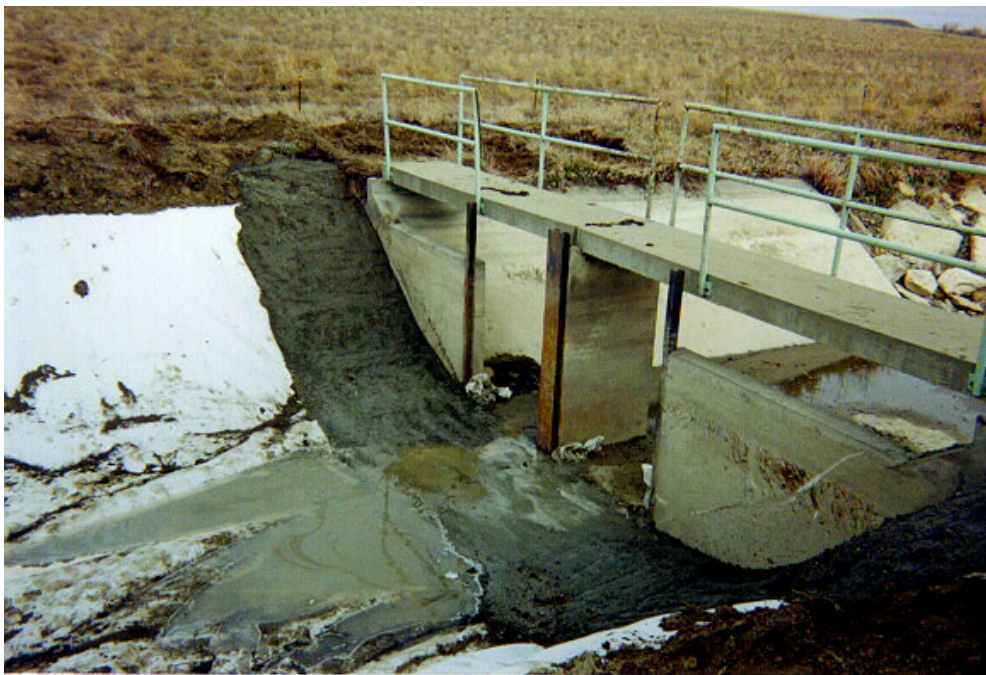
Photograph 18.—Completed downstream cut-off trench.

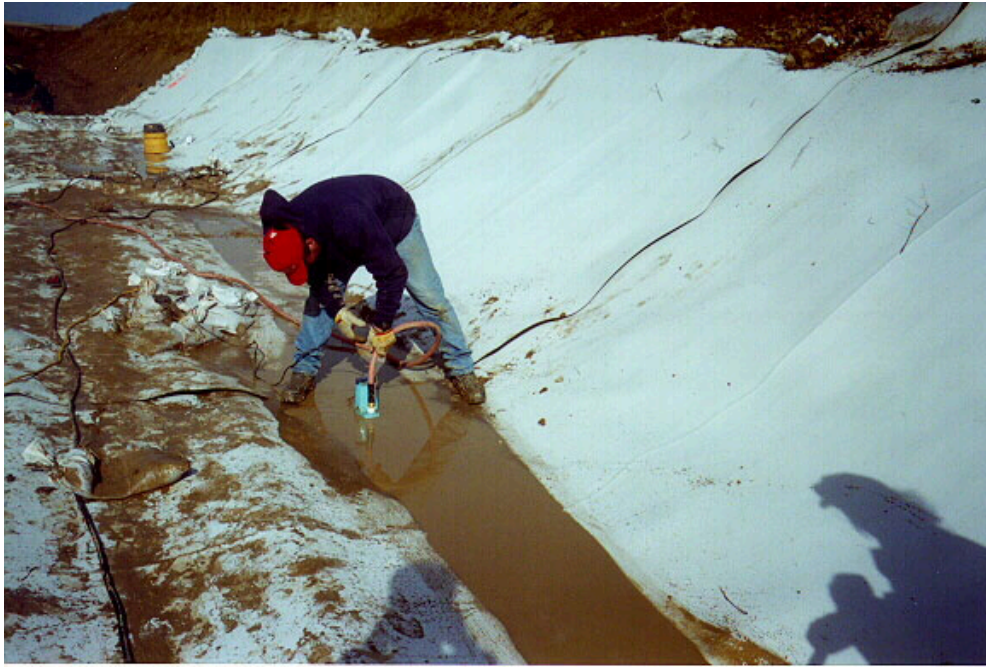
Photograph 19.—Heavy rains deposited water in the canal invert. A small pump is used to remove water from the area of the seam.

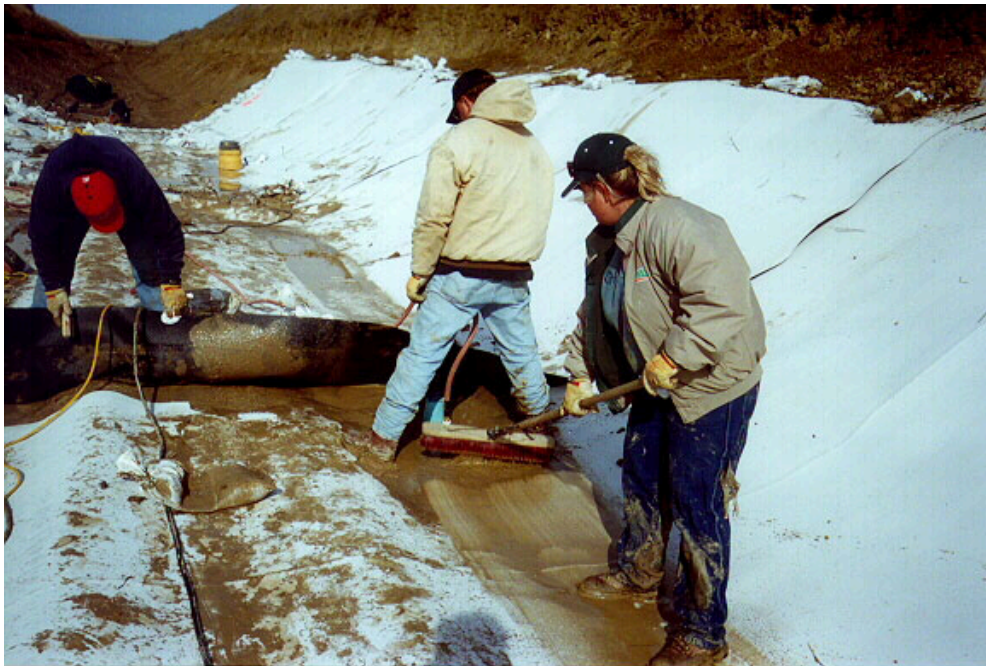
Photograph 20.—Standing water and mud had to be removed from the liner before seaming.

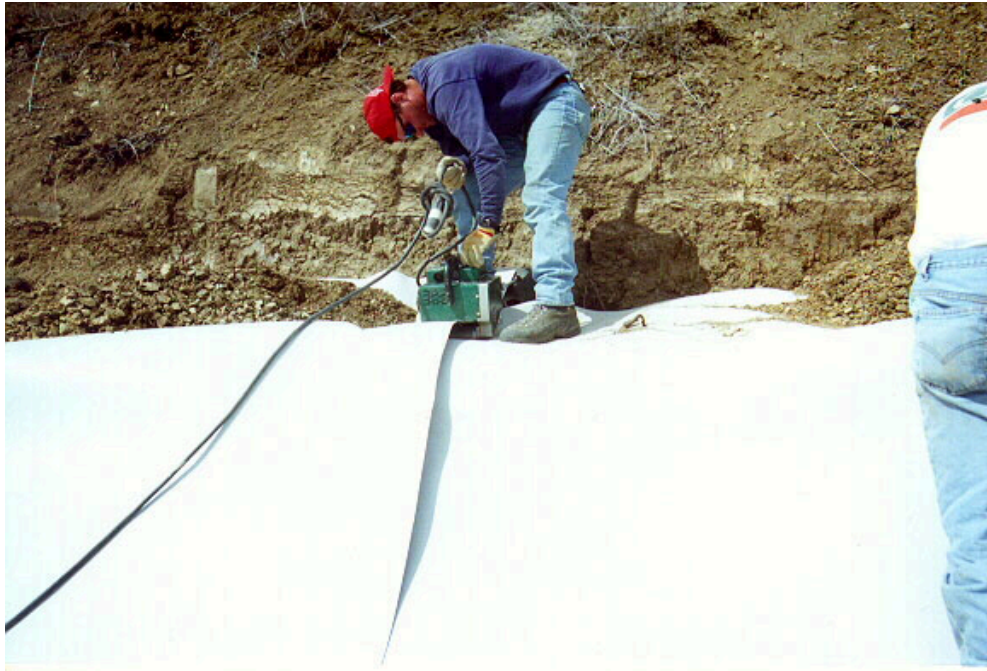
Photograph 21.—Self-propelled dual-wedge welder used for seaming.

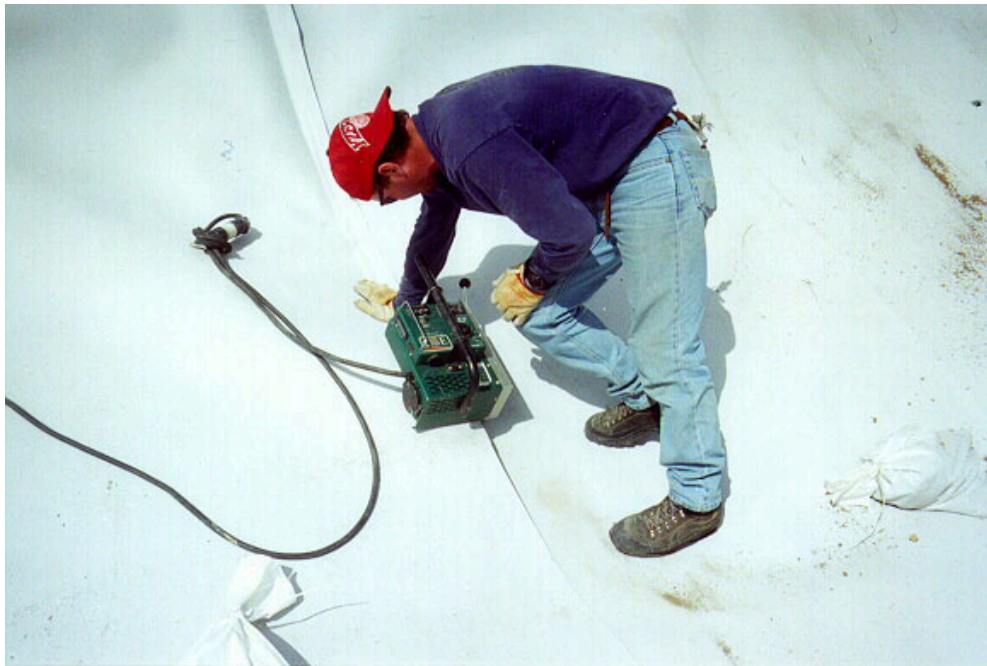
Photograph 22.—Welding technician applies pressure behind the wedge welder to remove small wrinkles in front of the wedge.

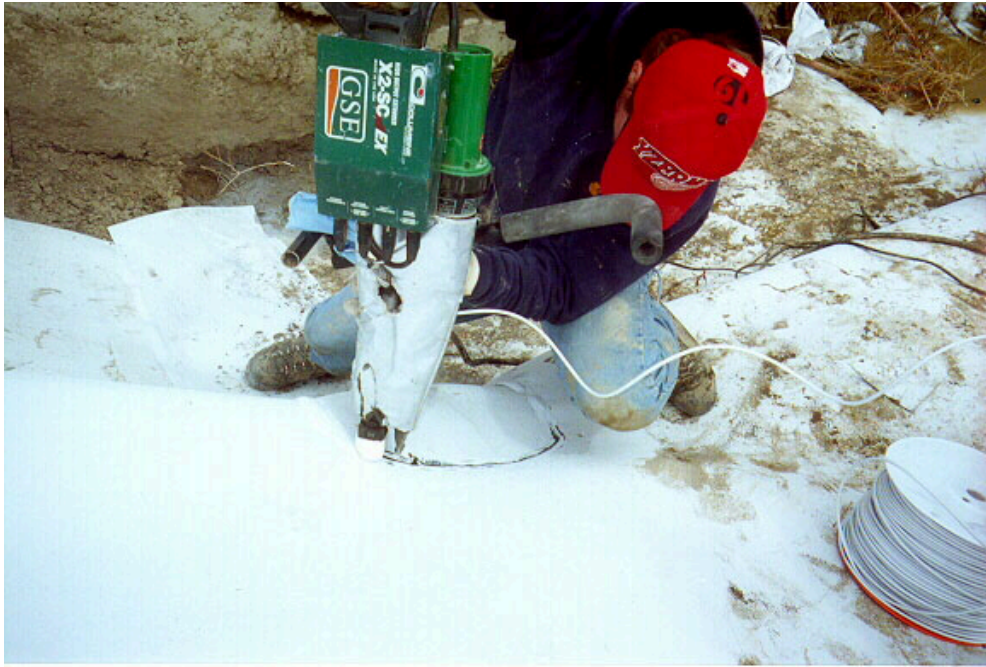
Photograph 25.—Welding Technician uses extrusion welder to apply patches to the geomembrane. Extrusion rod is white to match the liner.

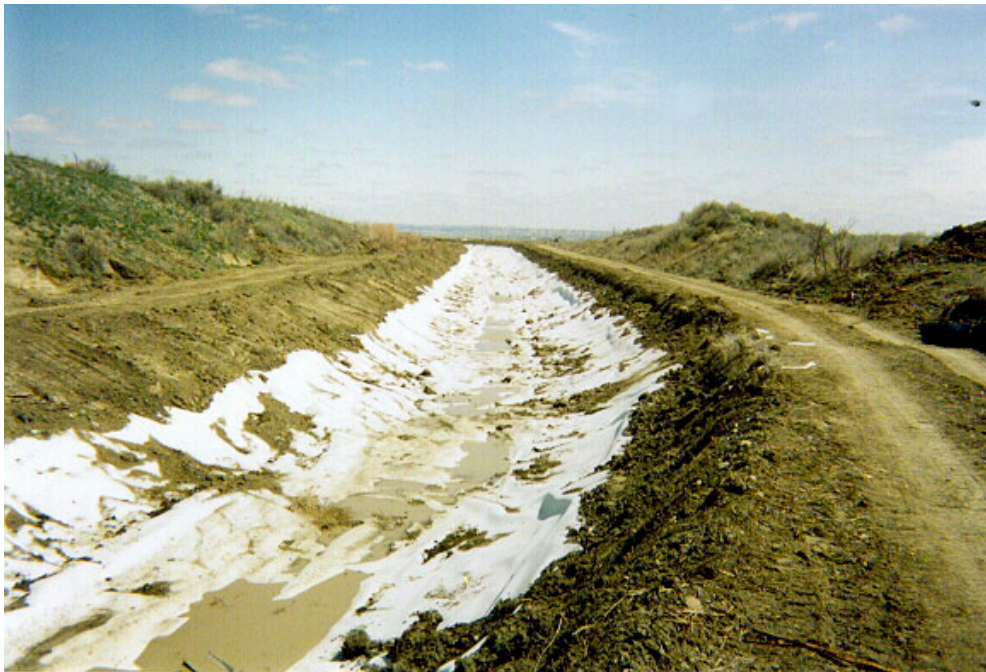
Photograph 26.—Completed test section. All seams have been welded, and anchor bench has been backfilled.

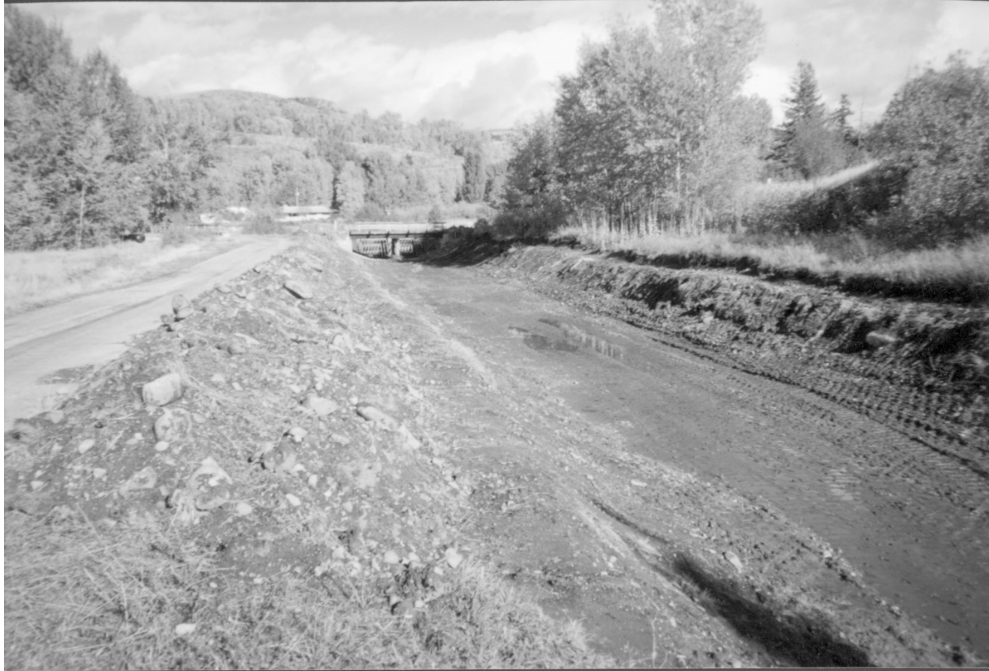
Photo 1.—The District performed extensive subgrade preparation by removing vegetation to 1 foot above the waterline, restoring the 1½:1 side slopes, and cutting a 2- to 3-foot anchor berm on each bank. The downstream section was too wet and was not lined at the time of the photograph.

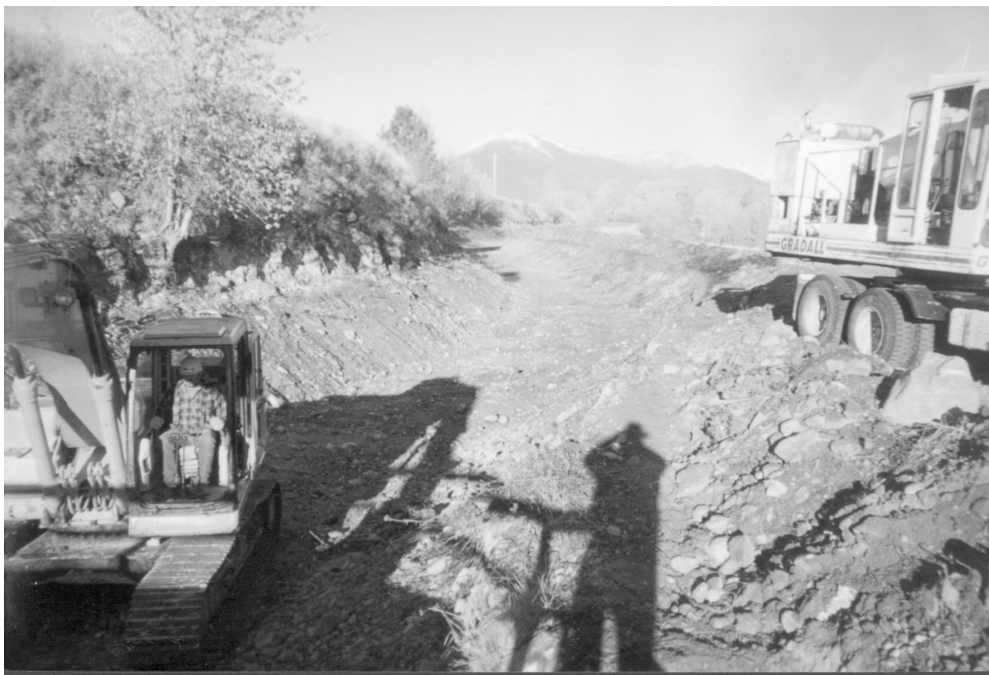
Photograph 2.—Upstream section ready for installation of lining.

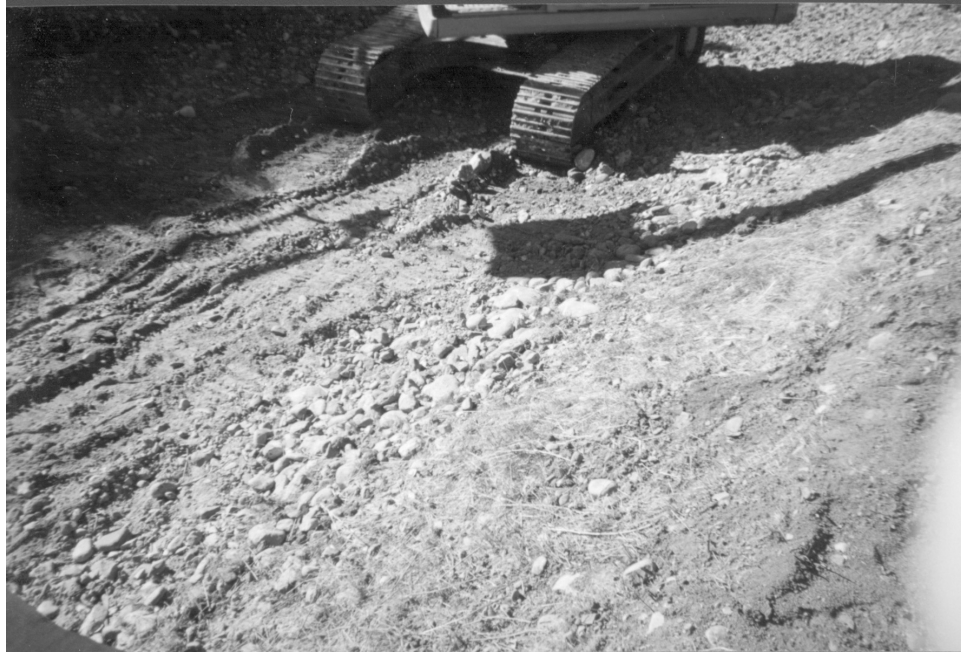
Photograph 3.—The prepared subgrade has large cobbles of up to 6 inches in diameter.

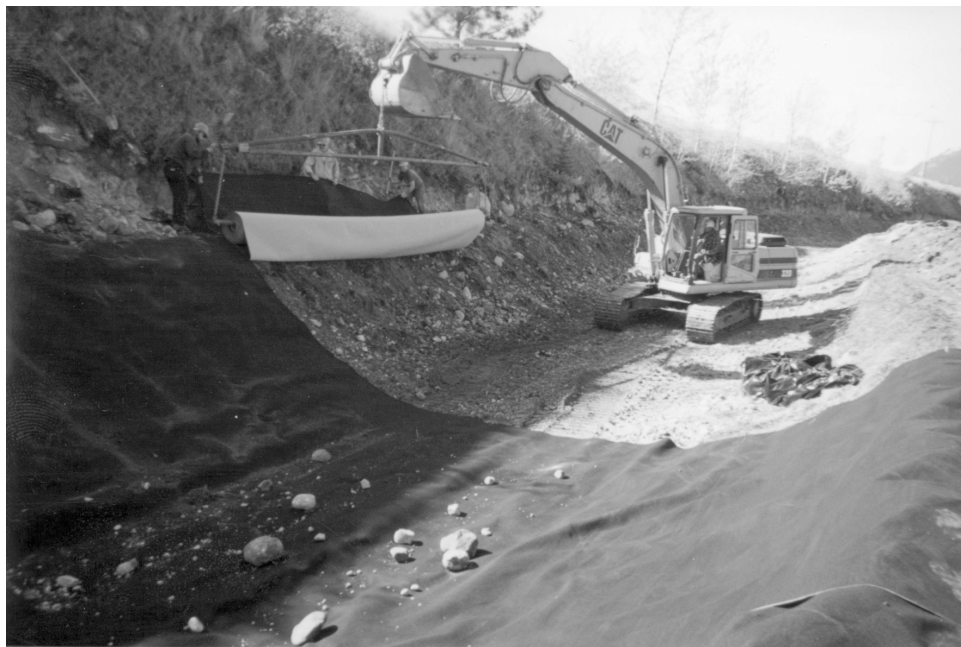
Photograph 4.—Trackhoe operating in the canal invert using a lifting bar to unroll geomembrane across the canal.

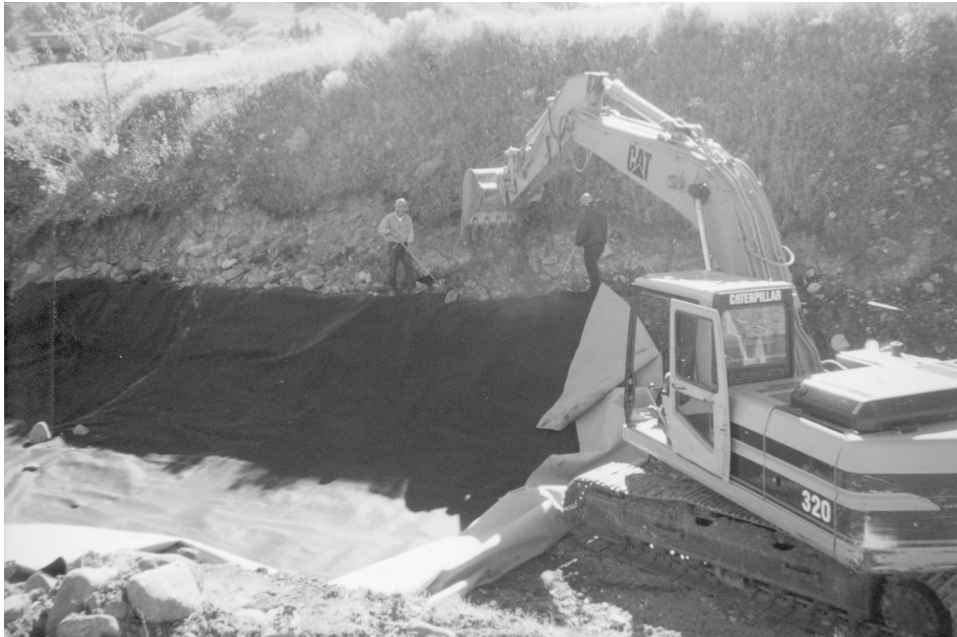
Photograph 5.—Trackhoe pulls down the far bank to cover geomembrane in the anchor berm.

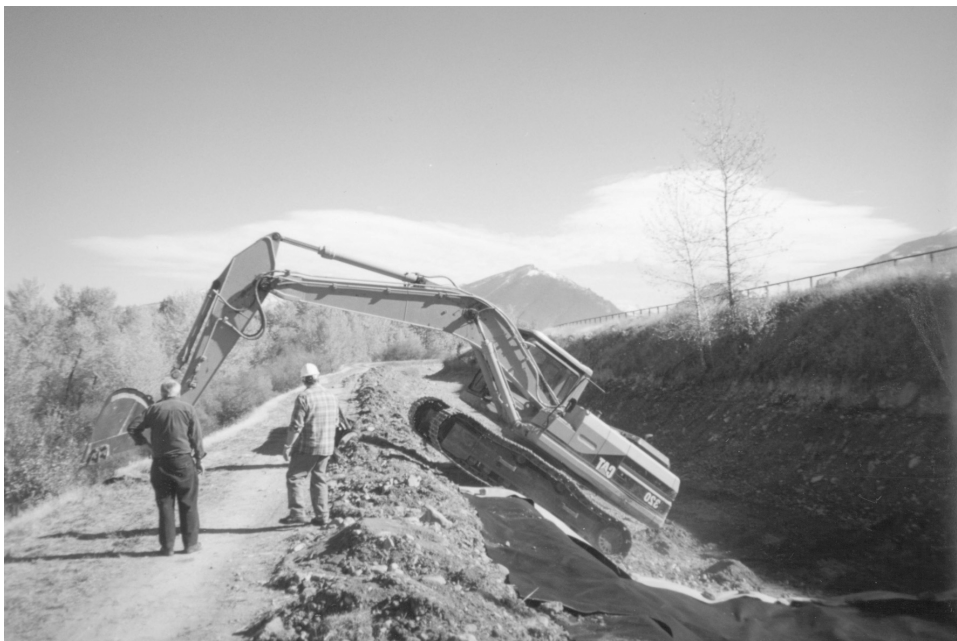
Photograph 6.—At the end of the day, the trackhoe drives up the side slope and out of the canal.

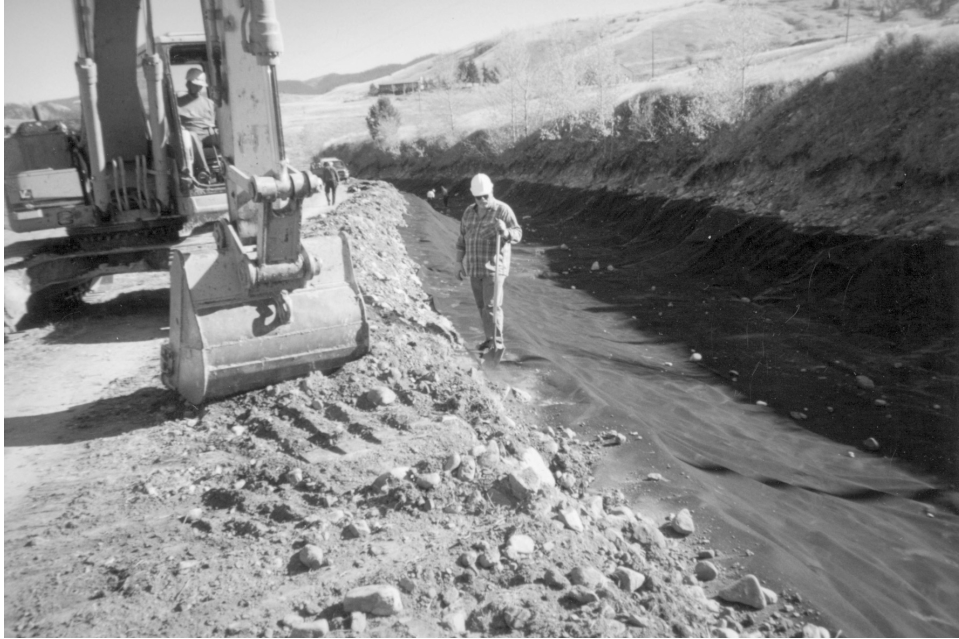
Photograph 7.—Trackhoe prepares to backfill the near anchor berm.

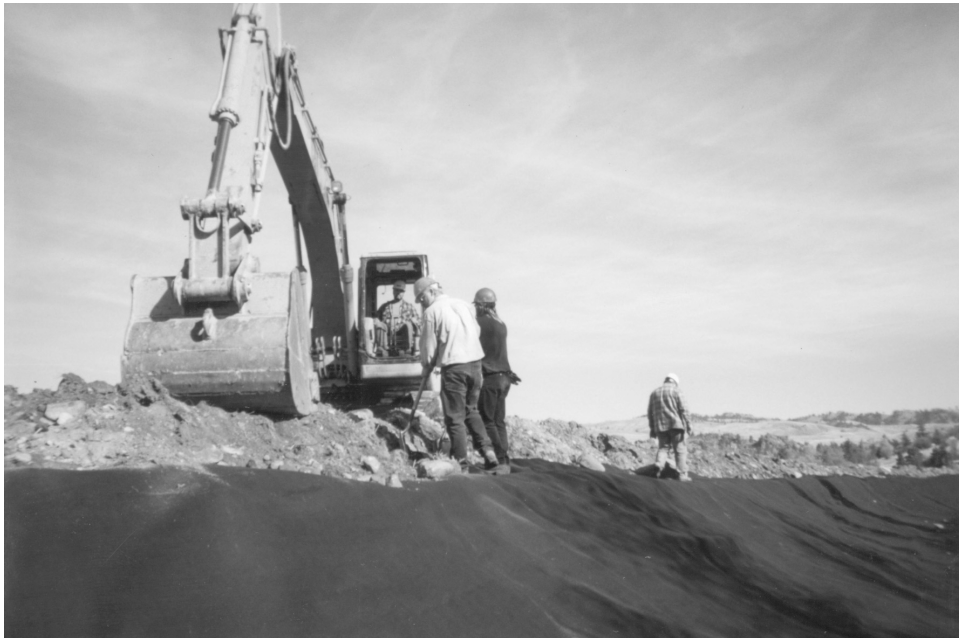
Photograph 8.—Laborers help backfill the near anchor berm.

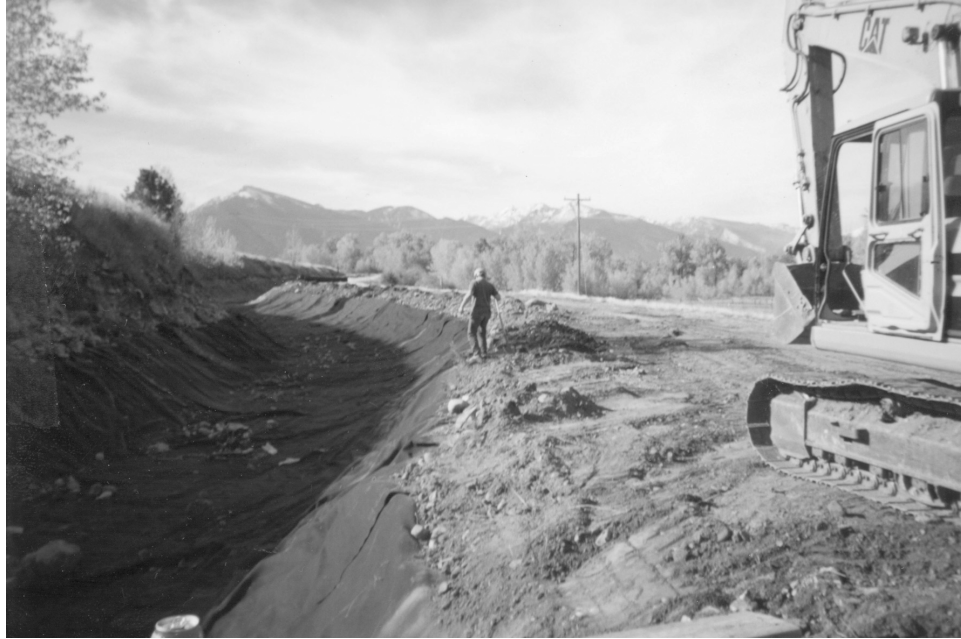
Photograph 9.—Backfill on near anchor berm is complete.

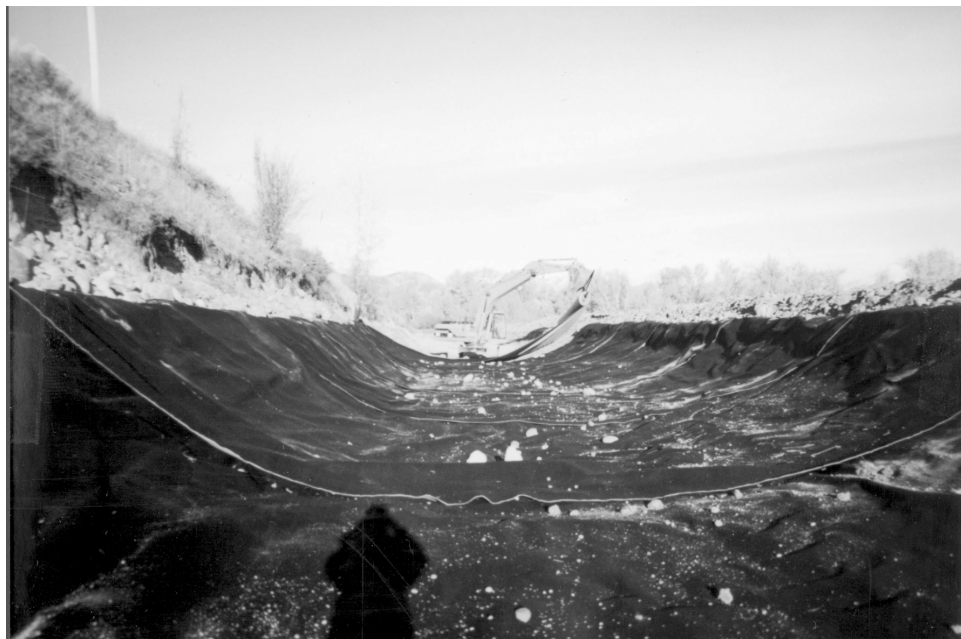
Photograph 10.—Overlapped seams are ready to be sealed. The trackhoe continues to lay geomembrane in the background.

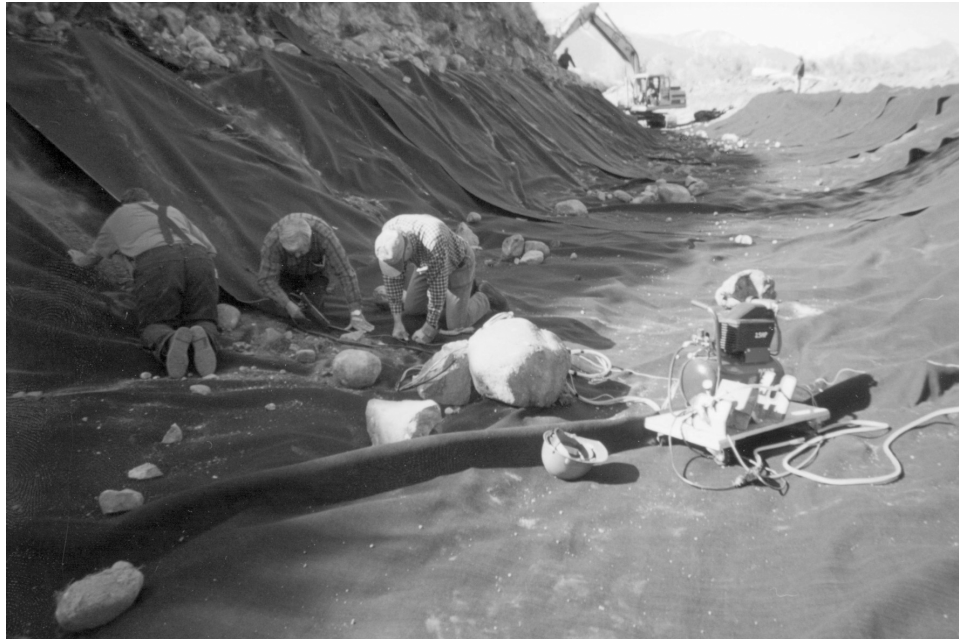
Photograph 11.—Three-man crew removes dirt from the seam and seals it with hot glue. Seams need to be held shut until the hot glue cools and sets.

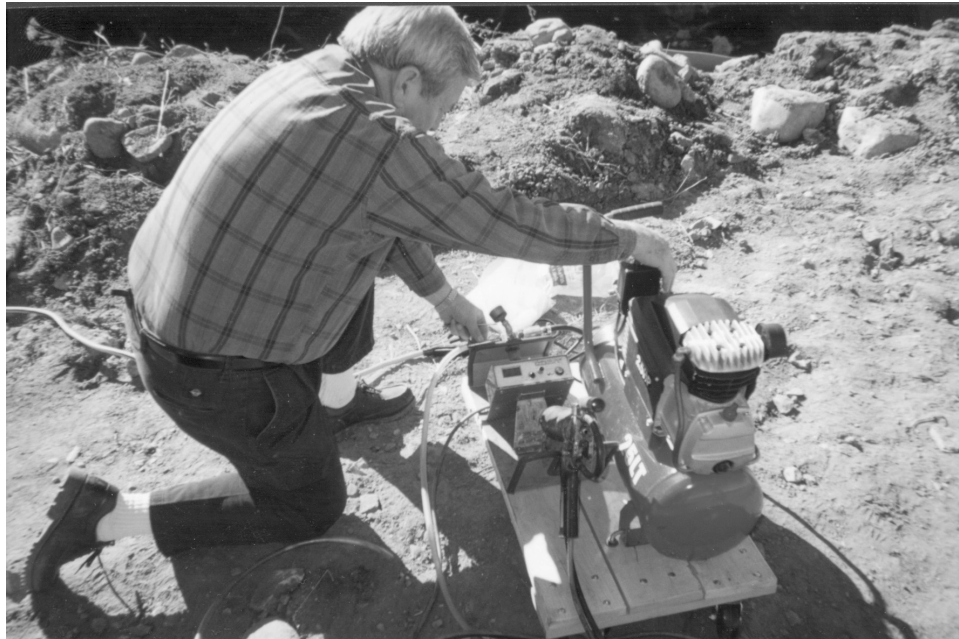
Photograph 13.—Closeup of the industrial hot-glue machine.

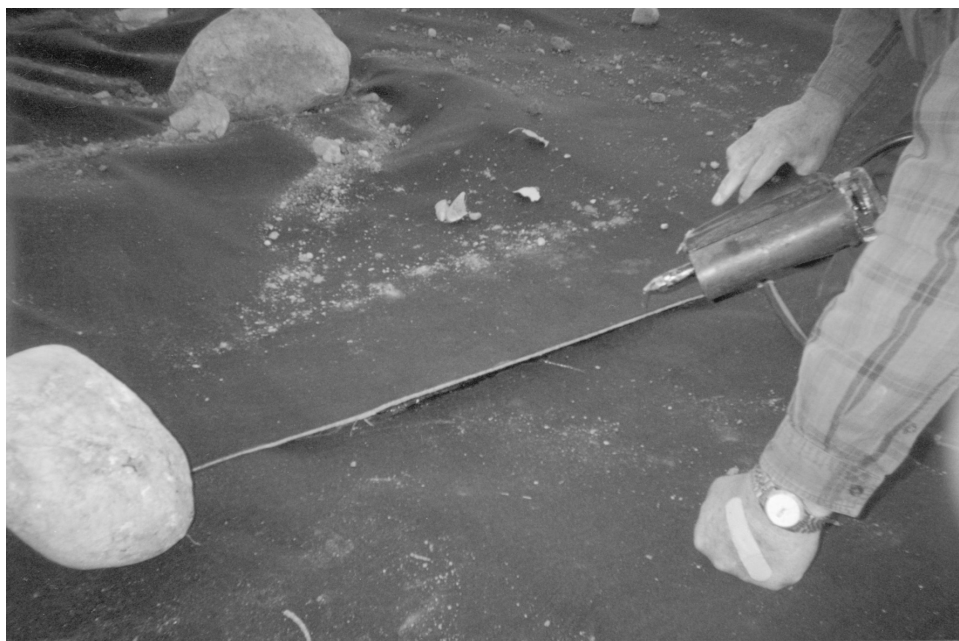
Photograph 14.—Closeup of seam with hot glue. Rock is placed on the seam to hold it together until the hot glue cools and sets.

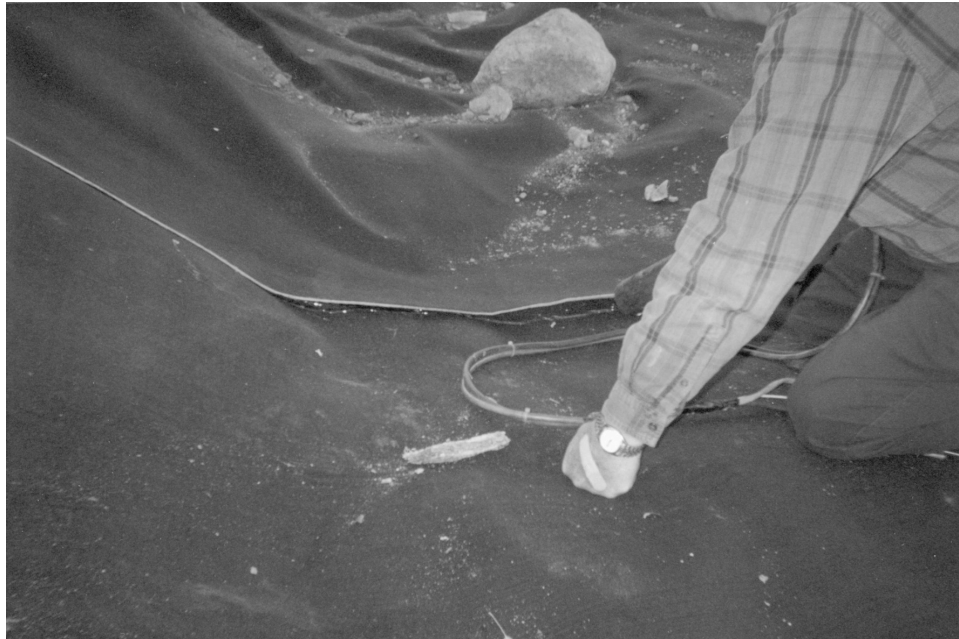
Photograph 15.—Hot glue is extruded into the seam in a ½-inch bead.

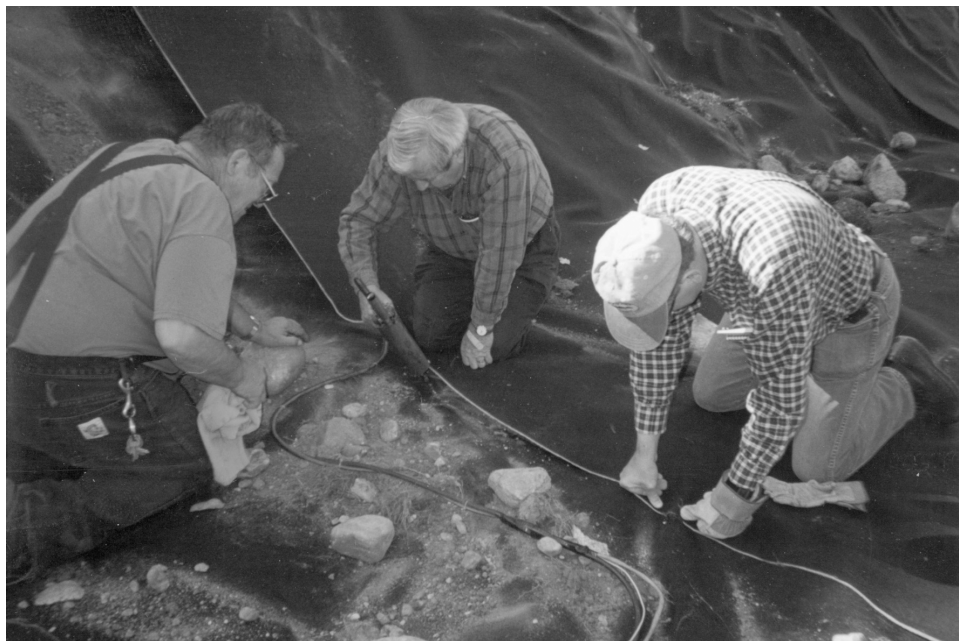
Photograph 16.—Three-man crew cleans the seam (removes loose dirt), applies hot glue, and holds seam shut until the glue cools and sets.

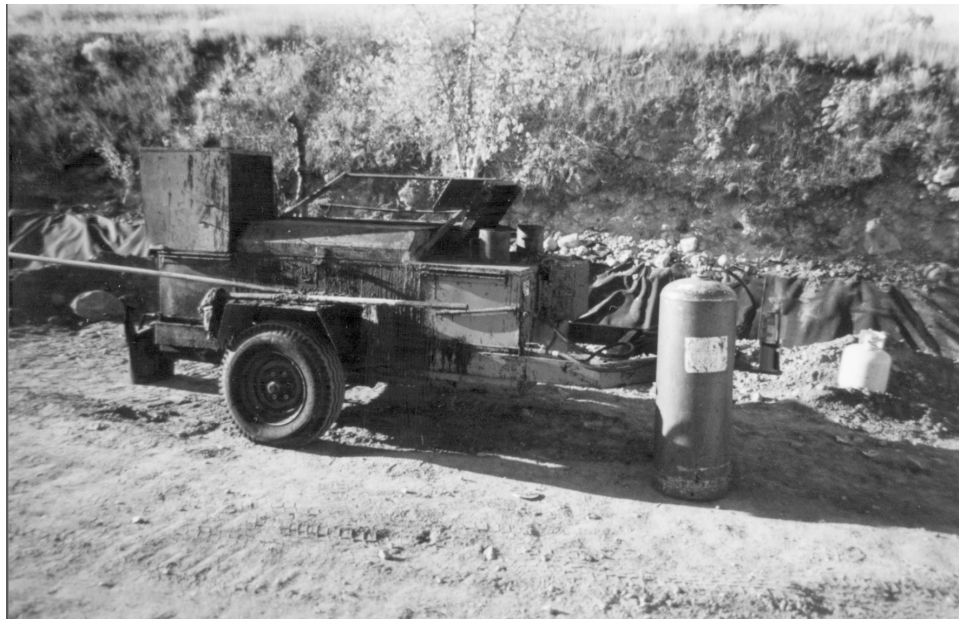
Photograph 18.—Hot tar was also used for seaming. Hot tar was supplied in a 100-gallon propane-fired kettle.

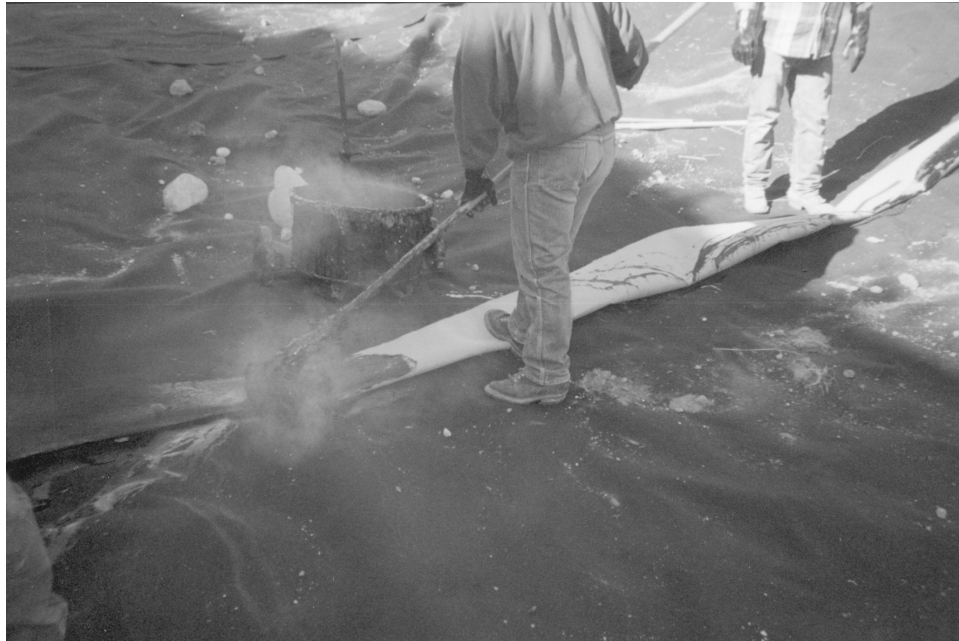
Photograph 19.—Geotextile is folded back, and hot tar is mopped onto both geotextile surfaces.

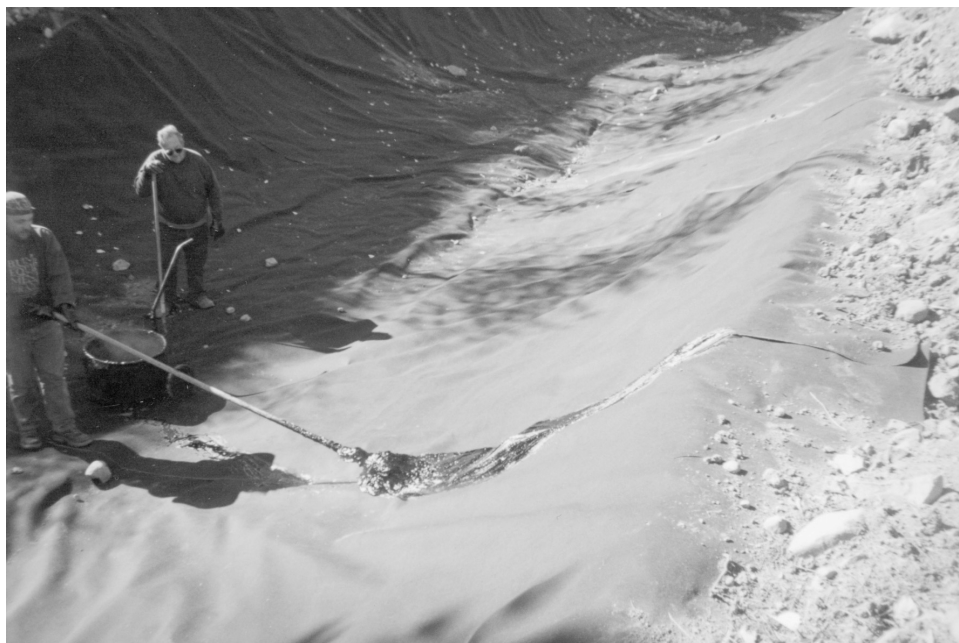
Photograph 20.—Upper geotextile is folded back into position, and the seam edge is buttered with hot tar.

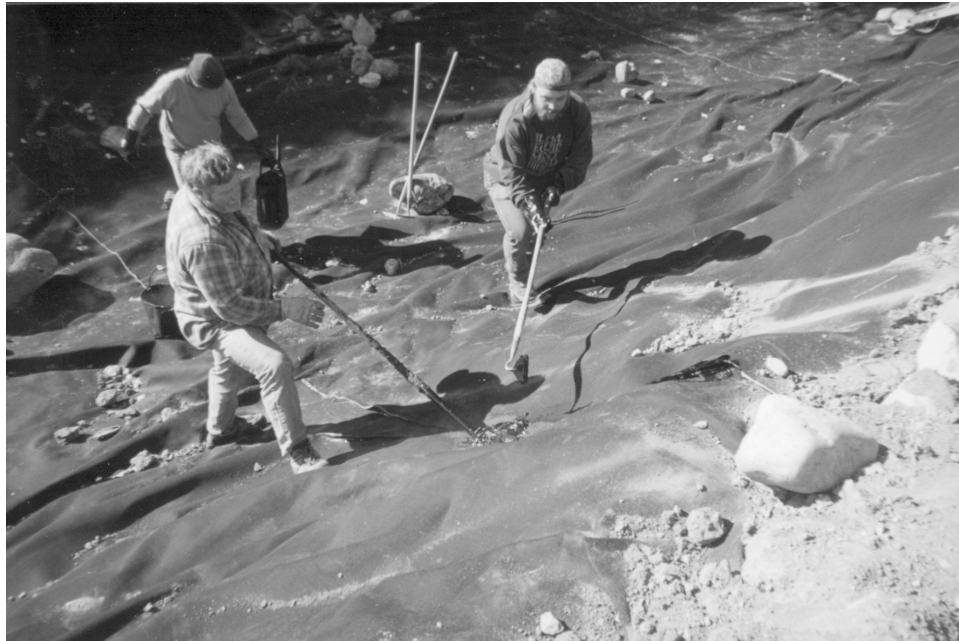
Photograph 21.—Laborer on right uses hoe to hold seam closed while hot tar cools and sets.

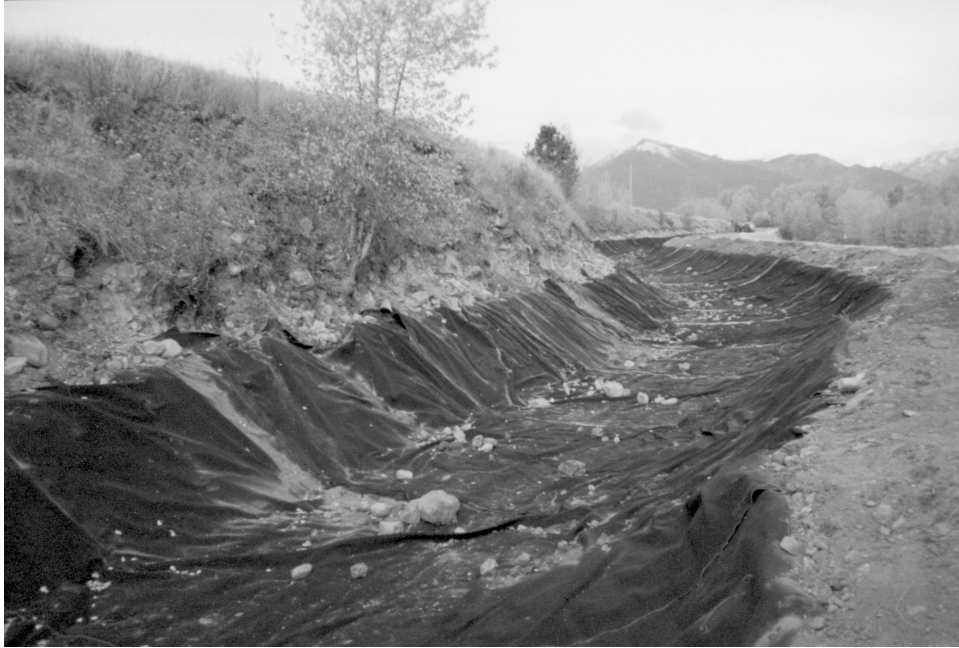
Photograph 23.—Finished installation.

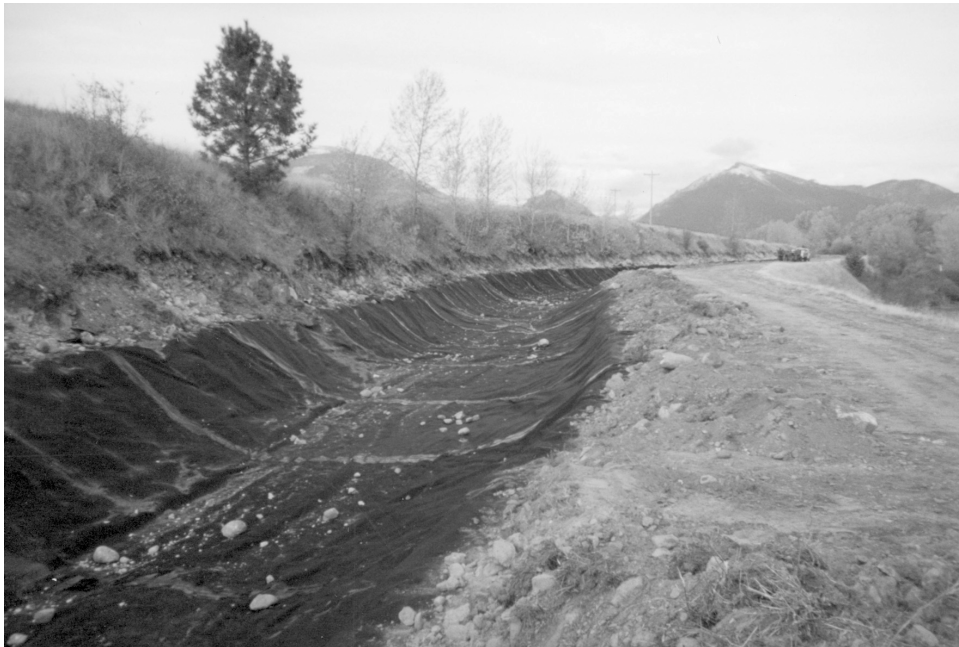
Photograph 24.—Finished installation.
